Go with the flow: conservation of a floating sculpture from 1961 made from glass fibre-reinforced polyester resin

Lydia Beerkens*, Sanneke Stigter, Thea van Oosten and Henk van Keulen

ABSTRACT Marta Pan's *Sculpture flottante, Otterlo* was commissioned by the Kröller-Müller Museum for a pond at the entrance of the new sculpture garden that opened in June 1961. The floating sculpture is made from glass fibre-reinforced polyester resin and is now coated with white paint layers. The top is connected to the base by a joint with a ball bearing, enabling it to rotate 360 degrees independently of the bottom part when activated by the wind. This smoothly shaped white lightweight water figure is a landmark for the public and an icon for the sculpture garden for generations of visitors to the Kröller-Müller Museum.

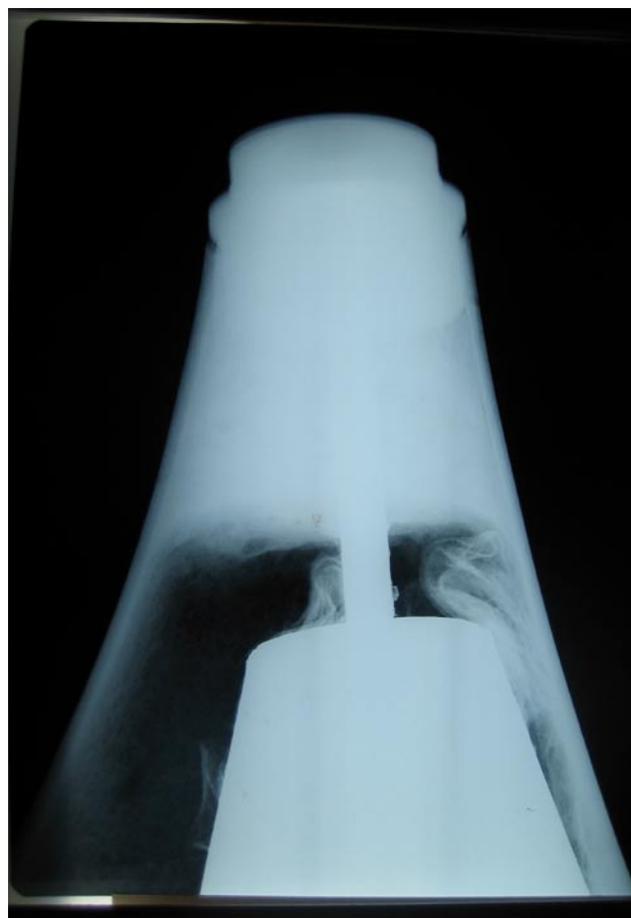
Figure 3 Collage of the X-ray photographs of both parts of the joint in *Sculpture flottante, Otterlo* (photo: Lydia Beerkens).

To obtain a better insight into the construction of the sculpture it was subjected to X-ray examination.¹⁵ A test series was made on selected areas using a mobile X-ray machine after which a continuous series of X-rays was made of the bottom edge of the hood in order to locate the added weights. Both sides of the ball joint were X-rayed, revealing the inner construction of the joint with reinforcement, counterweight and the exact vertical positioning of the joint (see Fig. 3). Radiographs of the bottom part however were unsuccessful: the lead bricks absorbed all radiation and concealed the distribution of the bricks at the bottom. Some repair patches, visible as small distortions in the surface, were revealed. Throughout the investigation, the X-ray films were reassessed from time to time; these revealed more information offering a better understanding of the production process and the material history.

The first focus was the ball joint. With gripper tongs the joint was loosened carefully. The large hood was separated from the bottom part with a forklift and both parts of the connecting joint were examined. The joint is constructed from aluminium and stainless steel. Inside are two solid polyamide sockets that enclose a steel ball. The tapered shape of the housing of the sockets allows limited torsion of the top part while turning.¹⁴ The ball was completely rusted; coarse grease, rust particles and dirt had added to the malfunctioning of this joint. The inner part of the joint only needed cleaning and some lubrication. The damaged ball was replaced by a new stainless steel ball.

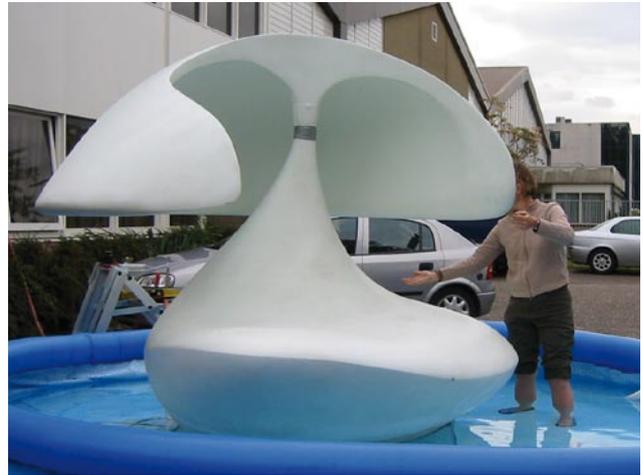
The next issue was how to calculate the amount of weight that would be needed to regain the correct floating position of the sculpture in the water. Consulting a physicist about the opposite forces of weight and upward pressure from the water made clear that the asymmetrical shape and ever-changing direction of forces by the turning of the hood made exact calculations about floating position and level impossible. The alternative was testing by trial and error. A large inflatable basin was set up as part of the first test (Fig. 4).¹⁶ The sculpture could be placed in the basin by lifting it with a forklift and girdles. First the bottom part was lowered slowly into the water. This part floated perfectly in an upright position without the hood, implying that the hood could be responsible for the sculpture's imbalance. The hood was joined smoothly to the bottom section with the new ball bearing in the cleaned joint. At this point the front of the bottom part dropped too deeply into the water and the reason for the malfunctioning of the rotation immediately became clear. With the front too deep in the water, the lower half of the joint leans and actually blocks the turning point. When the tail side was pushed down, a more upright position was achieved and the joint was unblocked: the hood swayed smoothly on the wind.

It was estimated that a weight of 37 kg on the back side of the bottom part was needed to lift the front sufficiently from the water to rebalance the sculpture in its upright position, allowing a full rotation of the hood. It is possible that some of the lead bricks had become loose during handling or transport of the object and had shifted position, thereby causing the imbalance. Adding a counterweight of 37 kg to the sculpture would cause the whole object to drop by some 2 or 3 cm in the water. This was considered to be a reasonably good solution that would not result in too much of a visible change, assuming it would be possible to add the weight.

Figure 4 Balancing out *Sculpture flottante, Otterlo* in the inflatable basin (photo: Lydia Beerkens).

The balance of the top part was tested separately. It needed some 750 g of additional weight on the short end in order to achieve perfect horizontal alignment again. The extra weight was added by inserting a line of fishing lead weights through a small hole drilled in a disguised area in the hood. The line was fixed in the hole to allow easy removal should this be

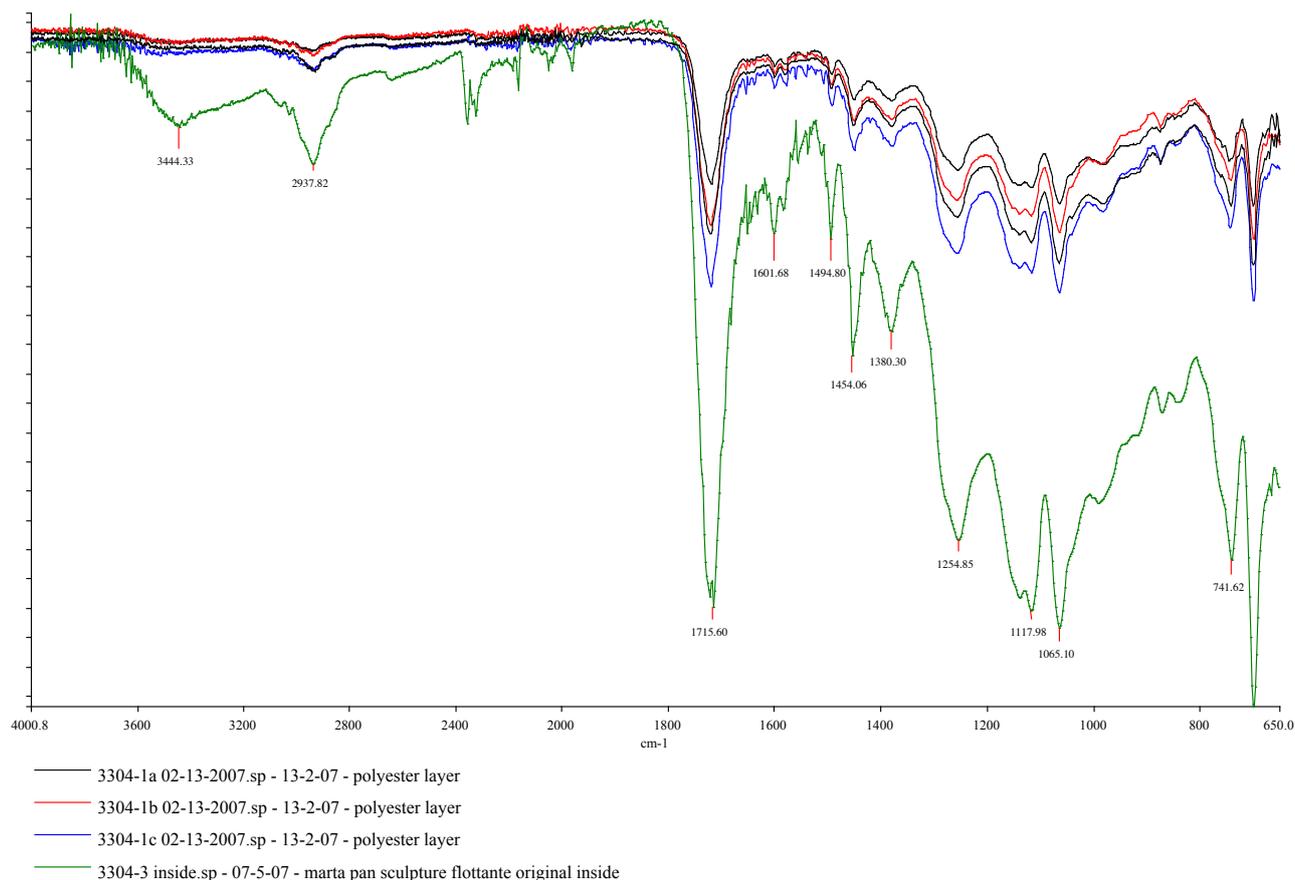
Figure 5 FTIR spectrum of polyester layers and first white layer from Marta Pan's *Sculpture flottante, Otterlo* (green spectrum) (Thea van Oosten, ICN).

The first white layer consists of adipic acid and a polyurethane, referring to an alkyd paint (a kind of polyester resin) modified with urethane linkages. The condition of this polyester paint layer is more degraded than the other polyester resin samples, as can be seen by an increase in C–OH functional groups at 3444 cm^{-1} , resulting in more oxidised and hydrolysed groups (see Fig. 5, green spectrum). The Cocoon layer consists of a polyvinyl chloride which, according to the manufacturer, is a polyvinyl chloride (PVC) polymer (see Fig. 6).

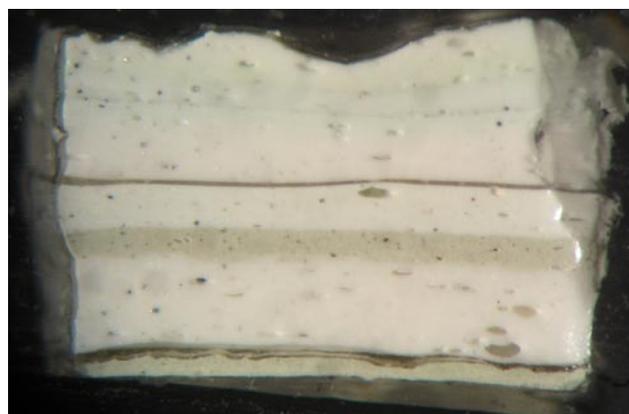
Figure 6 Sample 1A: cross-section from the spot where a small hole was drilled for examination of the interior with the endoscope. Stereomicroscope photograph (optical magnification 64 \times) shows several layers of coating, probably seven layers of Cocoon with slightly different tones of white. The thicker layers contain numerous air pockets (sample preparation and photo: Evelyne Snijders, SRAL).

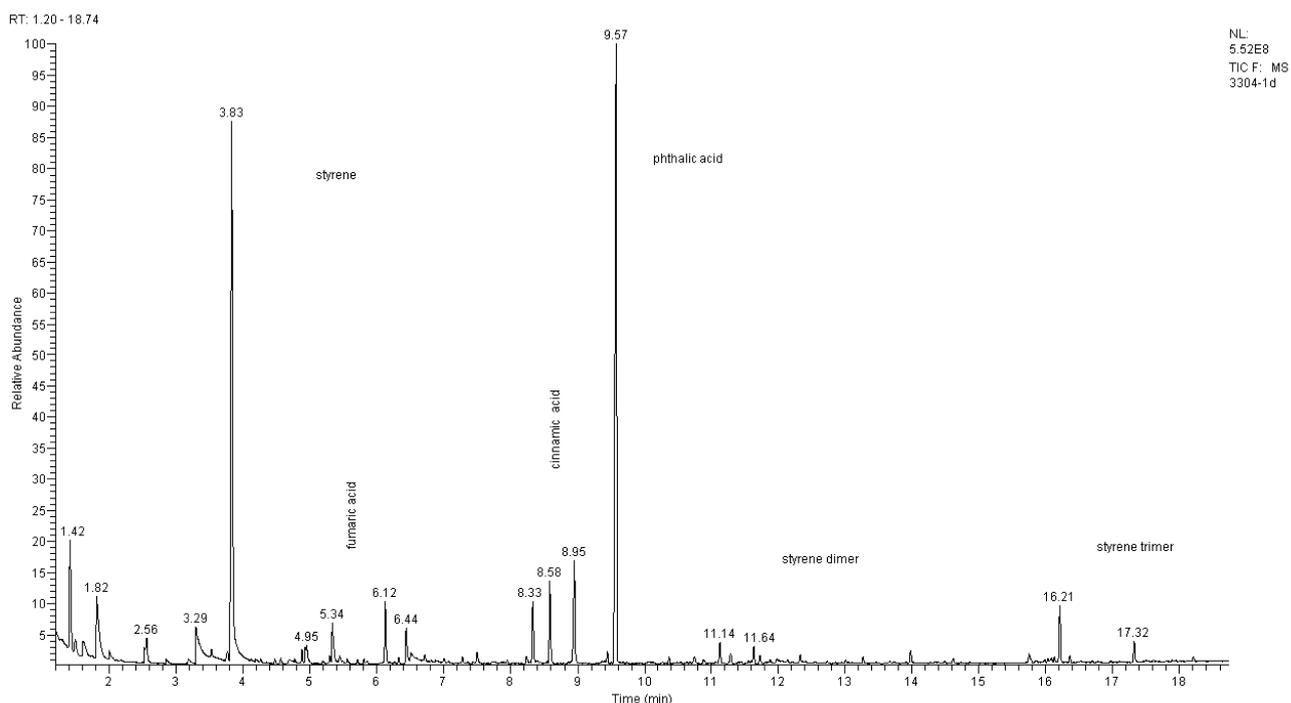
Figure 7 GC-MS spectrum of the glass fibre-reinforced polyester.

According to Py-GC-MS, the components or ‘building blocks’ of the polyester samples of the inside of *Sculpture flottante, Otterlo* are all similar and consist of fumaric acid, ethylene glycol and o-phthalic acid.¹⁷ The presence and peak height of fumaric acid, cinnamic acid and styrene dimer and trimer confirm that the GRP sample is in good condition (Fig. 7). No serious amount of degradation was established on the polyester samples due to the fact that the polyester was protected by the various Cocoon layers.
