UvA-DARE (Digital Academic Repository)

Retouching Monochrome Painted Metal Outdoor Sculptures: Tests for Claes Oldenburg's Trowel

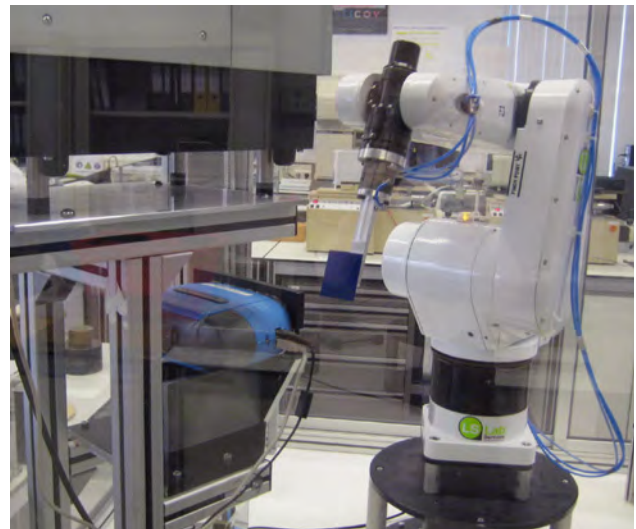
Figure 4 An automated robot was used to take color and gloss measurements during and after aging tests at AkzoNobel. Photo by Nikki van Basten.

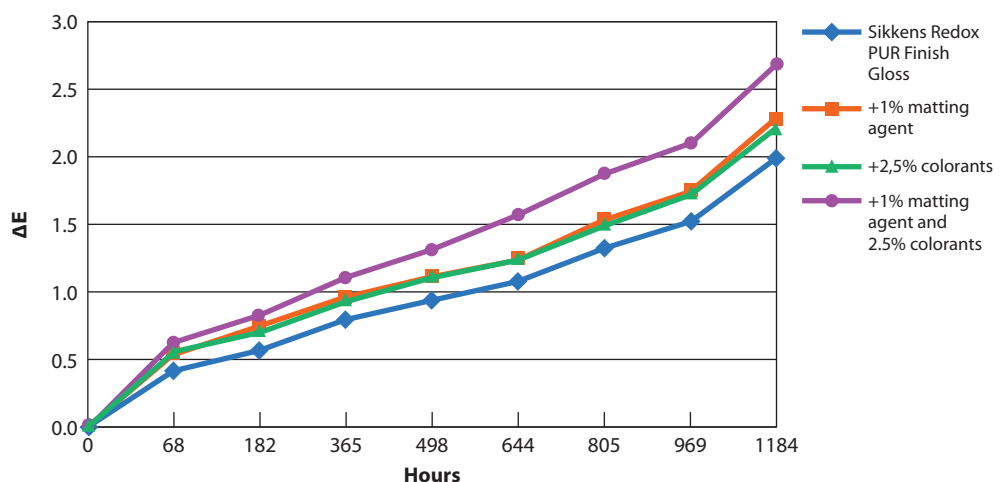
The one-component polyurethane paint showed an equally acceptable minor gloss change and ΔE curves, but visual inspection revealed that some areas had lost adhesion as a result of artificial aging. The protective layer of De IJssel's Zijdeglans Vernis PU on top of Golden Fluid Acrylics showed cracks after aging. Interestingly, the Golden Fluid Acrylics resin dispersion paint turned out to be quite stable, even without either of the two protective layers on top, the shift in color being slightly higher ($\Delta E =$ in the range of 2 to 5) than for both polyurethane systems ($\Delta E < 2.5$) (see table 1).
