*Published in:*  
Natural Hazards

# Geomorphological mapping and geophysical profiling for the evaluation of natural hazards in an alpine catchment

A. C. Seijmonsbergen<sup>1</sup> and L. W. S. de Graaff<sup>2</sup>

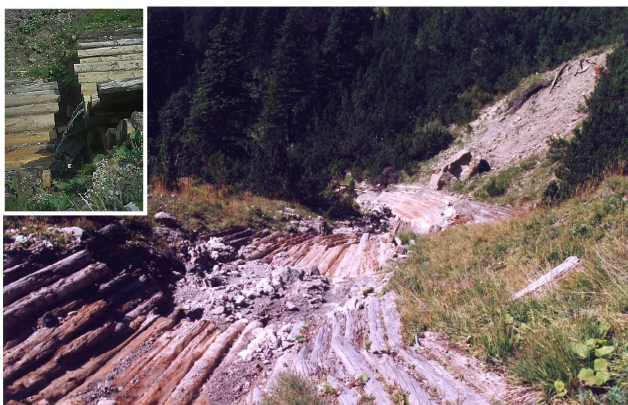
**Fig. 2.** The wooden drainage system is disrupted by the eroding power of debris flows, by small slides from the adjacent slopes (top right) and by differential movements within the landslide (detail top left), which leads to increased displacements rates.

displacements within the landslide and the erosive forces of debris flows (Fig. 2). The resulting infiltration increased the displacement rates. It was noticed by Wenzel (1985) that the landslide could pose a serious threat to Malbun; in the event of a sudden failure over 500 000 m<sup>3</sup> of material could be released. We therefore decided to evaluate the landslides and especially the displacement *pattern and depth* of the landslide in the central part of the catchment (see Fig. 3). The objectives of the study were: 1. to prepare a detailed 1:3000 geomorphological map that shows the spatial distribution of all landforms and processes; 2. to carry out a geophysical analysis over the gypsum underlain landslide, and 3. to present a GIS-supported hazard zonation of debris flows.

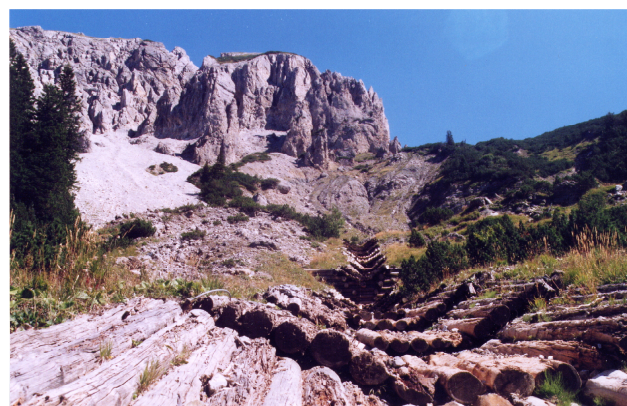
**Fig. 4.** Upslope view with the steep Hauptdolomite cliffs and associated scree slopes in the upper left part. The central part of the photo shows the major scarp of the gypsum underlain landslide. In the foreground the eroded drainage system is shown.

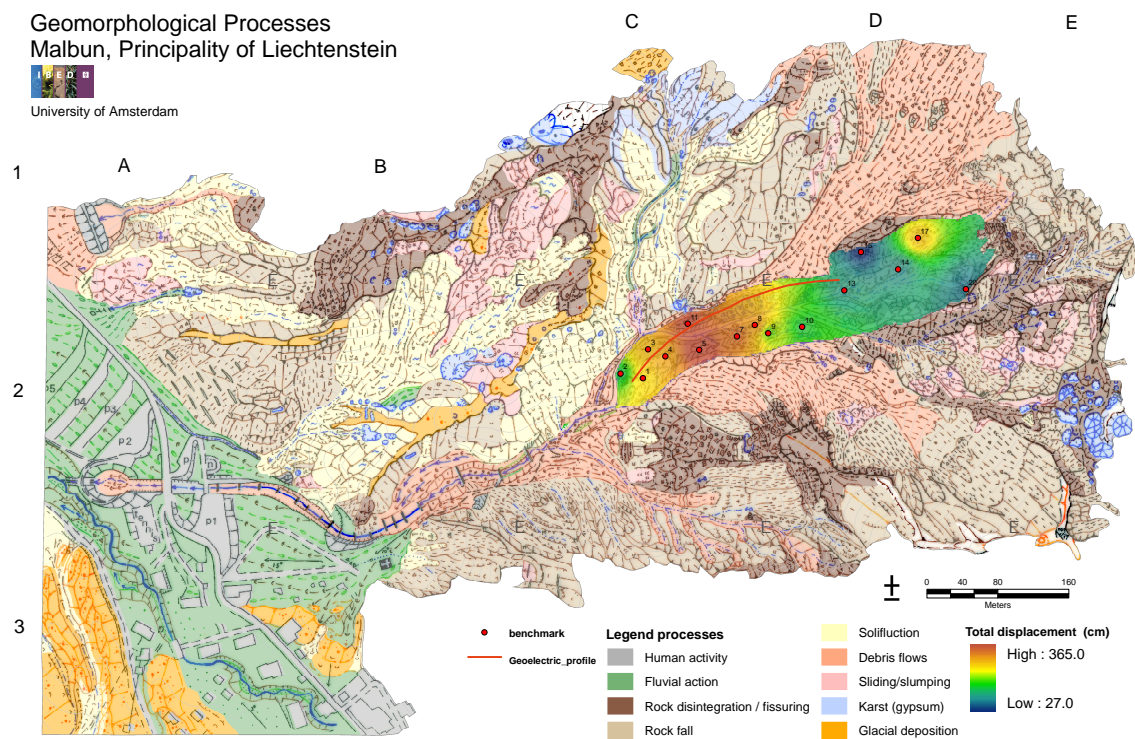
**Fig. 6.** Geomorphological processes Malbun, Principality of Liechtenstein.

In the central part of the Schlucher catchment a landslide underlain by gypsum is present (Wenzel, 1985). The outline of the central landslide is shown in Fig. 6. The back scar is located between 1850 and 1920 m, the side scars reach downslope to approximately 1800 m and expose heavily tectonized gypsum and anhydrite layers (Fig. 4). The lower end of the landslide is now situated at 1700 m altitude, which suggests a minimum displacement of 150 m. Rapid mass movements occur along the steep upper surrounding cliffs. Rock- and scree fall produces vast amounts of scree slopes which serve as source areas for debris flows, e.g. in square D1 (Fig. 3).

The location and relations between processes, material and form are derived from the geomorphological map (Fig. 3). The source area of the debris flow deposits are shown in the process attribute map (Fig. 6), which suggests that debris

In Fig. 6 the total displacements values over 15 years within the landslide indicate that the largest displacements occurred near the frontal section of the landslide. Benchmarks 5 and 11 have a vertical displacement of more than 3 m. This is related to local steeper slope gradients, which favours the development of tension cracks and sliding. This pattern can be attributed to fragmentation of the frontal slide masses into smaller slide units. After failure, these slides are too small to pose a serious threat to Malbun village. Benchmark no. 17 is located on an individual rock fall block that has moved down slope, resulting in a local optimum in the displacement rate.
