Go with the flow: conservation of a floating sculpture from 1961 made from glass fibre-reinforced polyester resin

Lydia Beerkens*, Sanneke Stigter, Thea van Oosten and Henk van Keulen

ABSTRACT Marta Pan's *Sculpture flottante, Otterlo* was commissioned by the Kröller-Müller Museum for a pond at the entrance of the new sculpture garden that opened in June 1961. The floating sculpture is made from glass fibre-reinforced polyester resin and is now coated with white paint layers. The top is connected to the base by a joint with a ball bearing, enabling it to rotate 360 degrees independently of the bottom part when activated by the wind. This smoothly shaped white lightweight water figure is a landmark for the public and an icon for the sculpture garden for generations of visitors to the Kröller-Müller Museum.

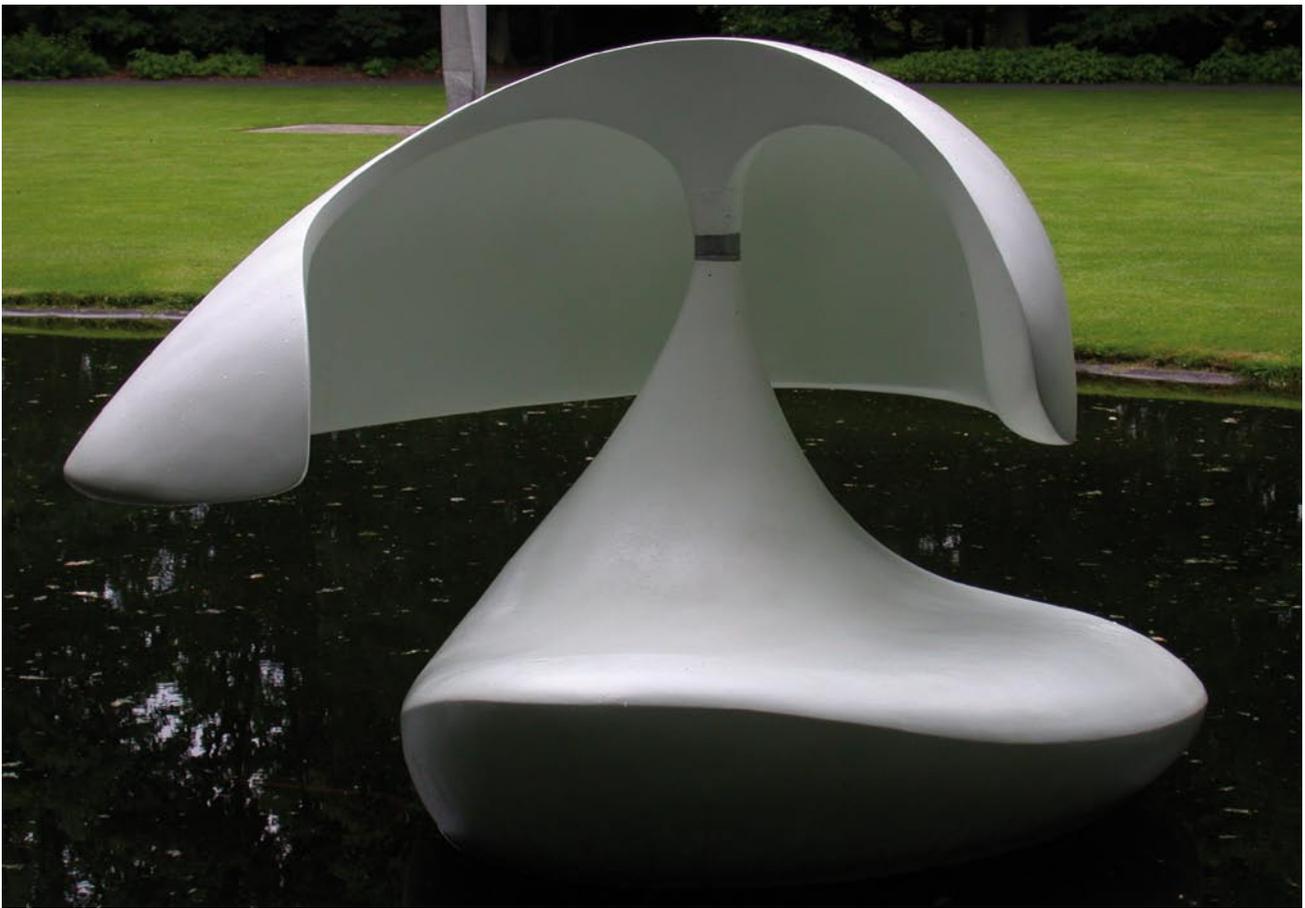
Figure 1 Marta Pan, *Sculpture flottante, Otterlo* (1960–1961) in the sculpture garden of the Kröller-Müller Museum in Otterlo (photo: Sanneke Stigter).
